Impact of Grenfell Tower fire disaster on polyisocyanurate industry^{*})

Grazyna Mitchener¹⁾

Abstract: The paper summarizes commonly available information on the fire of the Grenfell Tower, which took place in Central London on 14 June 2017. The fire was very similar in its nature to several other spectacular fires at tall buildings, which have happened around the world since 1999 but unlike the previous one, the London fire claimed an enormous number of victims – 71. The tragic outcome of the fire was blamed on a combination of several human and natural factors: faulty evacuation procedures, unsuitable fire extinguishing equipment, mistakes by the housing association managing the building, lacking fire safety provisions in the tower, weather, confusing building regulations, *etc.* However it was established that the main reason for so tragic an outcome of this fire was the speed of fire spread *via* decorative aluminum composite materials (ACM) containing polyethylene (PE), installed on the outer of a building as a part of a rain-screen cladding system. The other part of the system was polyisocyanurate (PIR) thermal insulation. The paper focuses on the role of PIR in this fire a

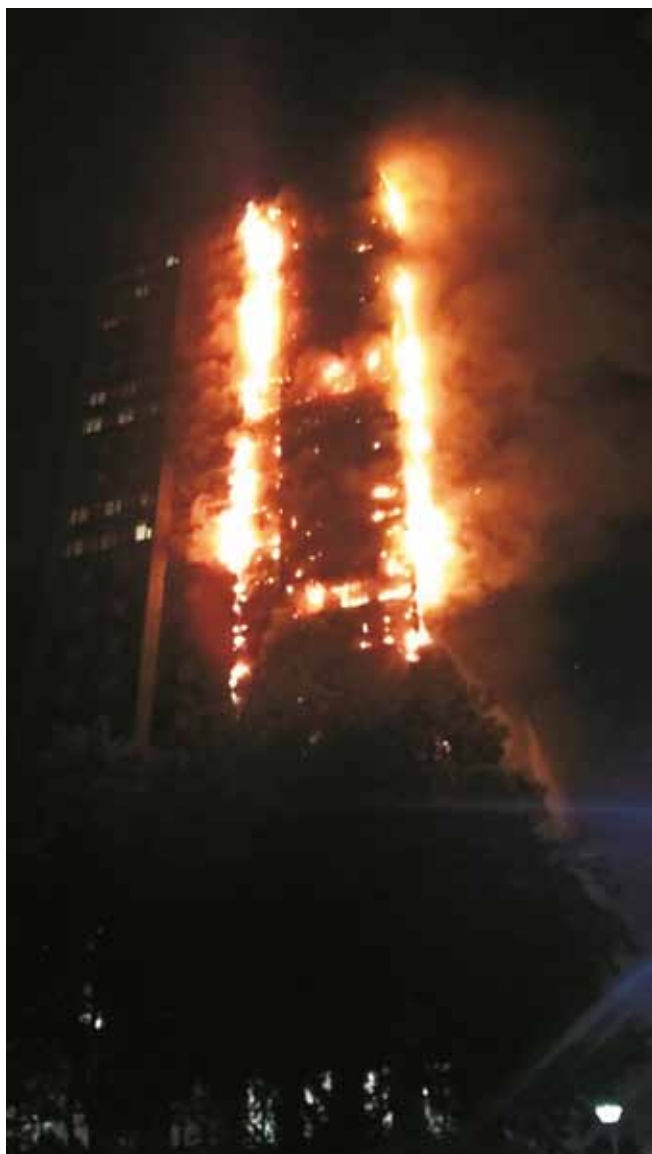
Grenfell Tower was a 23-storey residential building in Central London. In the middle of the night on 14 June 2017 a faulty fridge caught fire in a flat on the fourth floor. The fire quickly managed to get out through a window and then with unprecedented speed at first shot up to the top of the building in less than 30 minutes and then within 2 hours engulfed the whole building outside and inside (Fig. 1).

Fig. 1. Burning Grenfell Tower 14 June 2017 London (with permission of Rex Features)

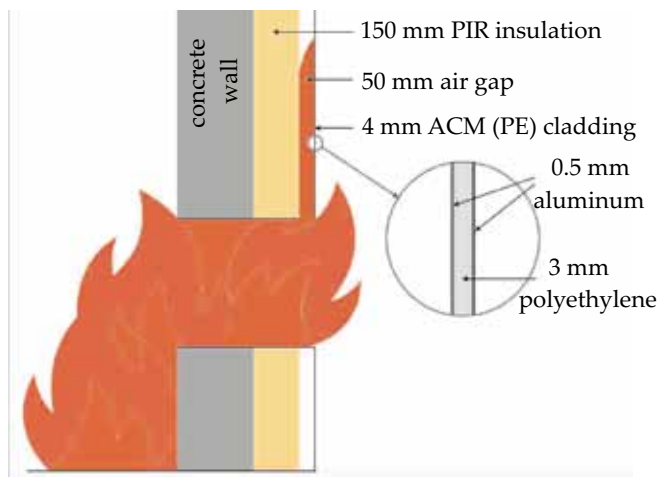
Fig. 2. The structure of the rain-screen cladding installed on the Grenfell Tower and the mode of fire spread *via* "chimney effect"

The cladding was a thermal insulation system consisting of 10–15 cm thick polyisocyanurate (PIR) boards and aluminum composite material (ACM) panels separated by a 50 mm air gap (Fig. 2).

It was believed that once the initial fire got out of the first flat, it began to be fuelled by the highly flammable polyethylene present in the ACM (PE) and then spread rapidly due to a "chimney effect" of the air gap (Fig. 2). Naturally the chimney effect propagates fire mainly

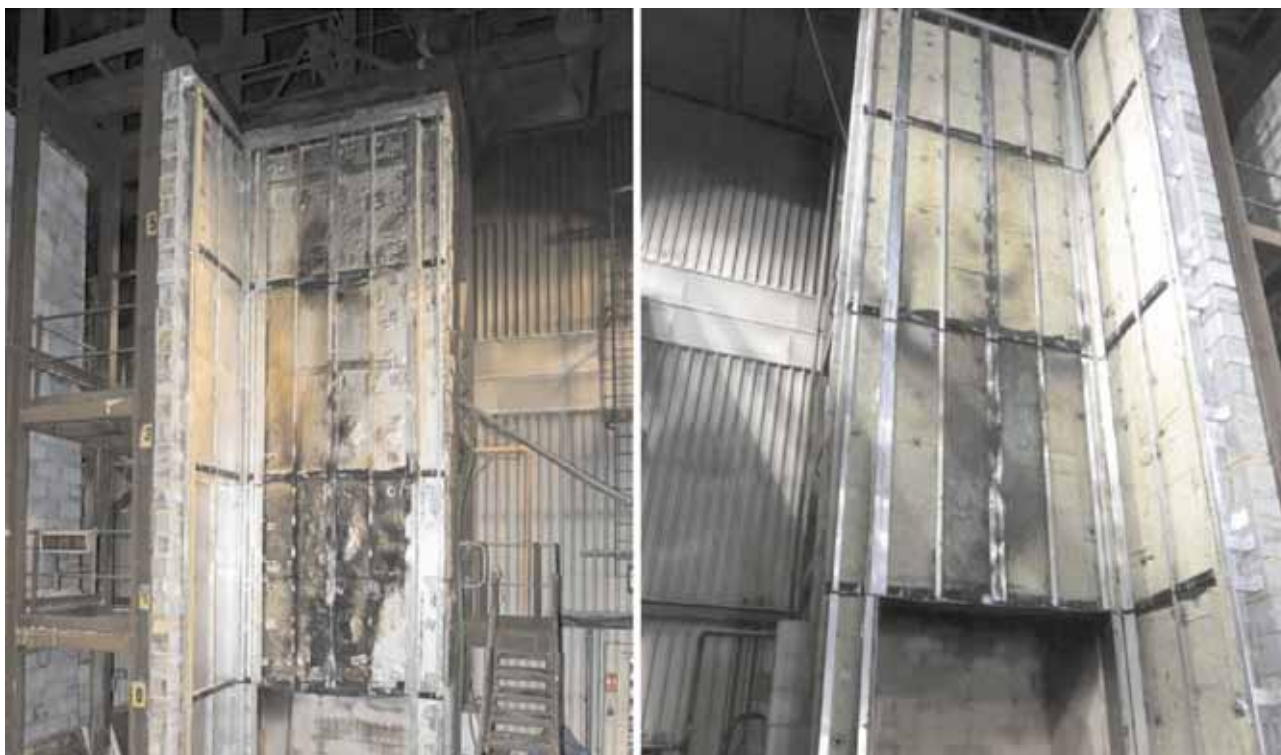
Both tests in which ACM (PE) was used over PIR insulation (test no. 1) or stone wool (test no. 2) had to be terminated after 7–8 minutes, due to the flames spreading well above the 8 m height of the rig but neither of the insulation products showed much fire damage (Fig. 4). These tests clearly replicated the speed of fire propagation observed on the Grenfell Tower.

Fig. 4. The PIR (left) and stone wool insulations (right) after BS8414 tests no. 1 and no. 2 and removing the ACM (PE) decorative cladding
